# Manhole Inspection Summary

Manhole # S41G\_\_018MH

Insp Date: **5/19/08 11:14 AM**

**Location** Address: **142 lloyd st**

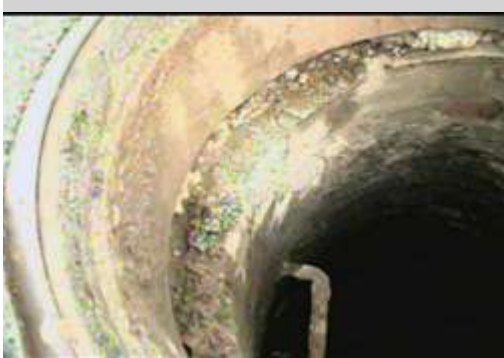
Defect 1

Offset: **2** (in.)

offset

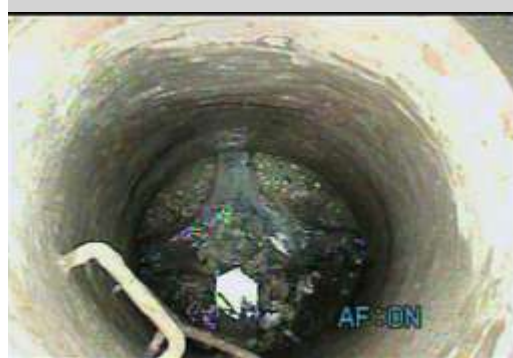
Defect 2

Condition: ☐ Sound ☐ Cracked ☐ Root Intrusion ☐ Deteriorated ☐ Leaks ☒ **Debris**

Count: **5** Missing: **0** ☒ **Corroded**

corroded steps; channel & bench debris

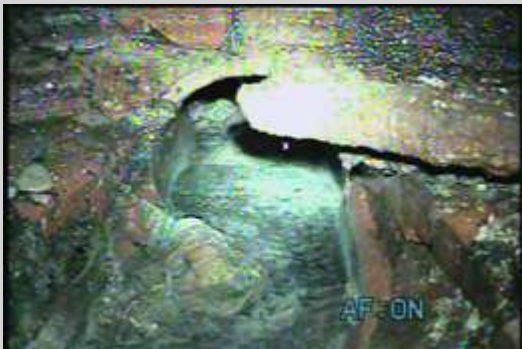
3 O'Clock Inflow

Deposits: ☐ None ☐ Mud ☐ Sludge ☒ **Debris** ☐ Grease

Silt Depth: 1 (in.) Deposits Extent: **Light**

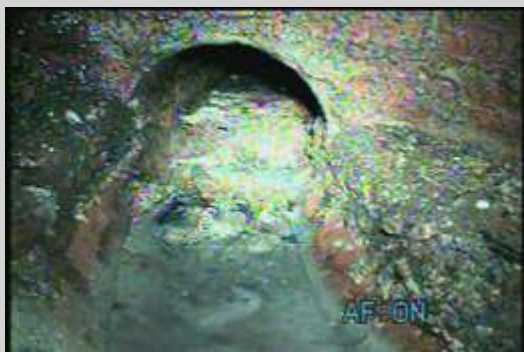
9 O'Clock Inflow

Deposits: ☐ None ☐ Mud ☐ Sludge ☒ **Debris** ☐ Grease

Silt Depth: 4 (in.) Deposits Extent: **Heavy**
